# KINGSTON FOSSIL PLANT

ANNUAL ASH POND DIKE  
STABILITY INSPECTION  
2008

Prepared by: Jamey Dotson  
Date: February 15, 2008

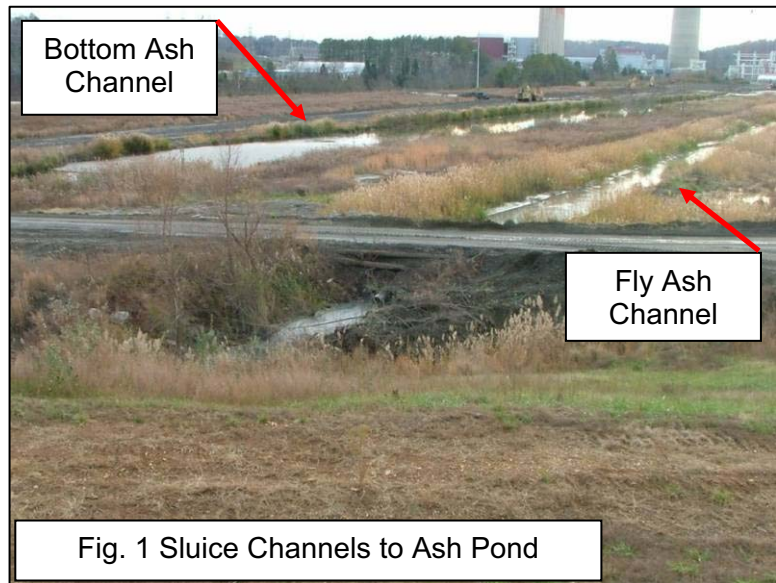
Fig. 1 Sluice Channels to Ash Pond

Fly ash is sluiced into an adjacent channel to the bottom ash channel where it flows into the main ash pond. The fly ash channel was cleared of vegetation last year. Both channels flow northeast into the active ash pond. See Figure 1 and drawing API 2008.

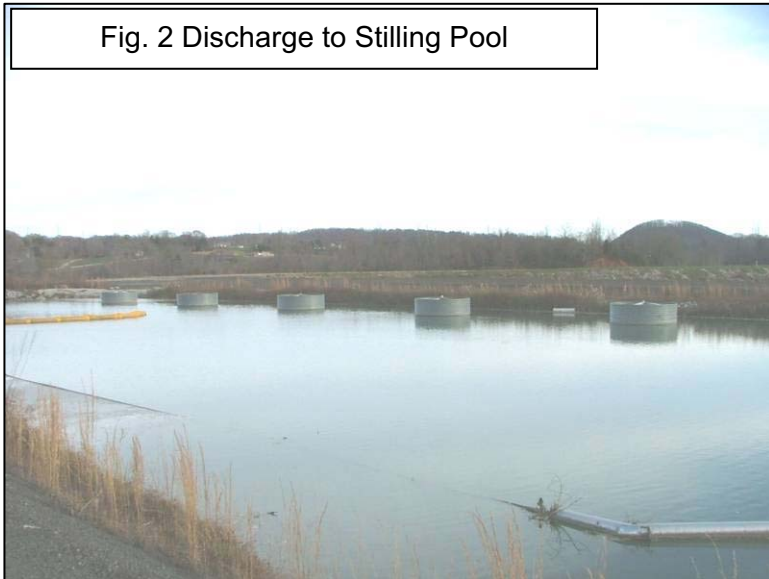
Fig. 2 Discharge to Stilling Pool

Sluice water flows from the active ash pond into the stilling pond through the five spillways constructed in 2005 (see Figure 2), as part of a project to allow more accurate accounting of free water volume. The old plant constructed spillway (Kennedy Weir) was taken out of operation at the same time. From the stilling pool, the water discharges into the plant intake channel via six standard spillways equipped with discharge diffusers constructed in November 2003. Many of these structures have vegetation and brush growing inside them, which needs to be removed.

- Remove vegetation growing inside spillway structures.
- Investigate the use of spraying to inhibit vegetation growth on the interior dikes of the stilling pond.

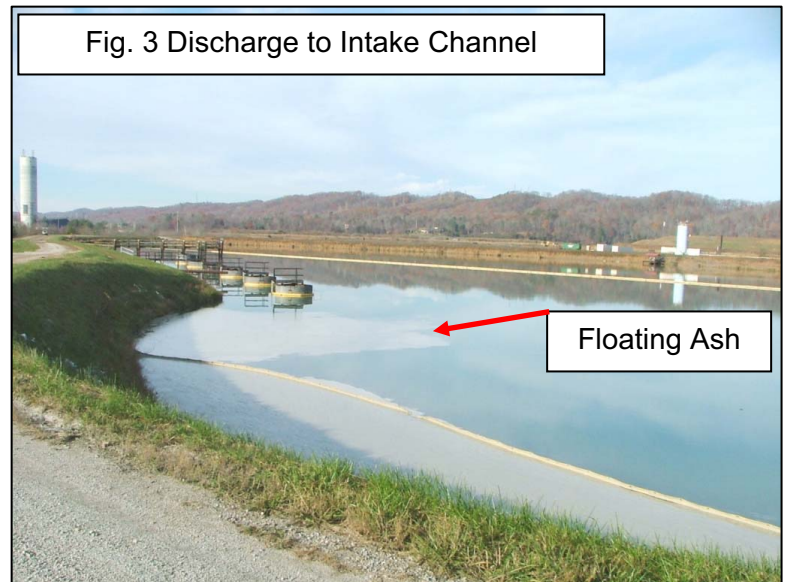
Large amounts of floating ash have been contained within floating skimmer booms (two inside both the active ash pond and the stilling pool). This ash should be removed in order to prevent an accidental release. Some of this ash has breached the booms and is near the discharge structures. See Figure 3. The seeps along the toe of Dike C and below the toe of the dike along the intake channel, known since the early 1980s were not visible during this inspection.

- Remove ash floating on the surface of the ash and stilling ponds.
- Repair rutting in the access and dike roadways. Fill with bottom ash and regrade as required to promote drainage.

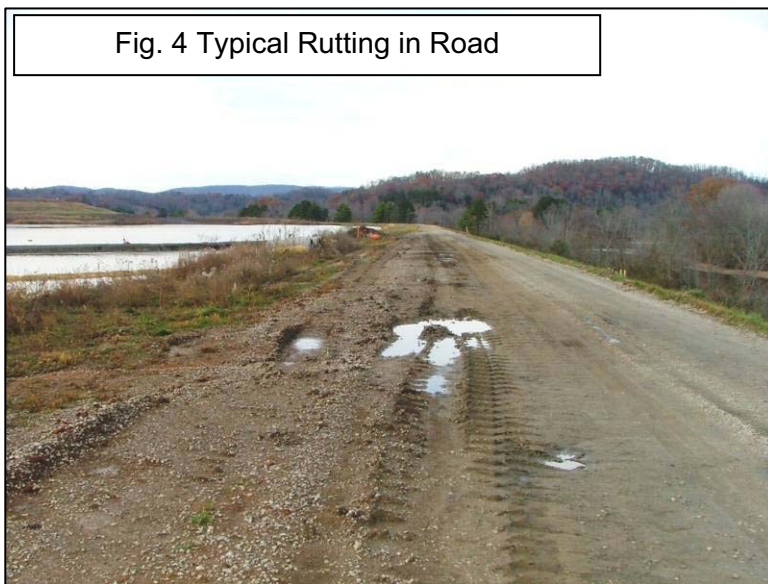
Some of the dike roads exhibit areas of rutting, see Figure 4. This photo is typical of the conditions of the roads, although it does not appear to be a significant problem

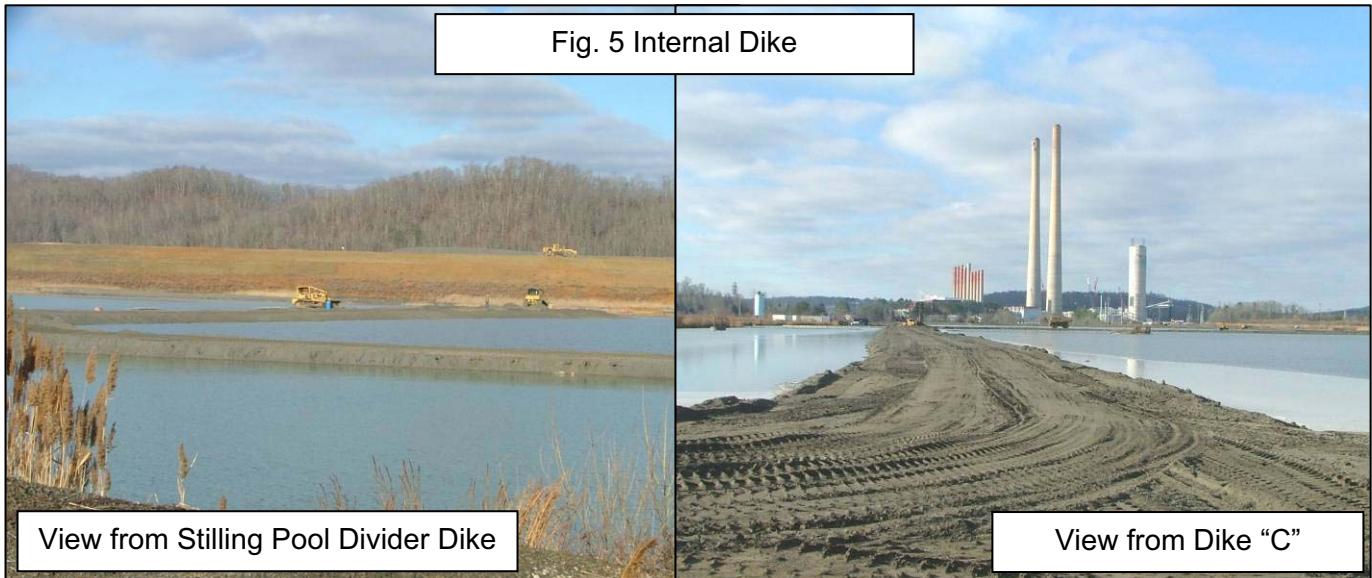
Construction of an internal divider dike inside the active ash disposal area is currently underway. The divider dikes will be constructed to build a base of fly ash for a dredge cell expansion, which will eventually cover approximately half of the existing main ash pond. See Figure 5.

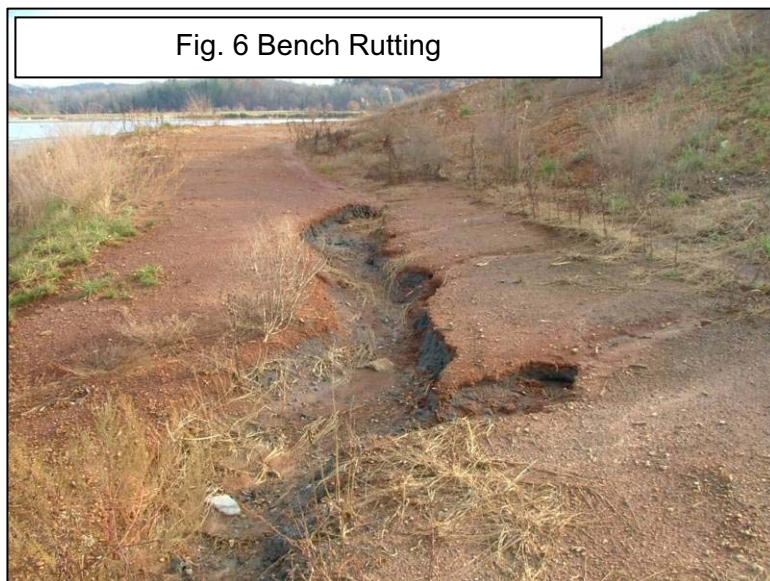
interim cell to the main ash pond. Water flow into the interim cell is essential for dust control. The divider dike between this cell and the active pond appeared to be in stable condition with some bench rutting and poor vegetation. There was one section of standing water approximately 100 feet in length. As much as practical, these areas should be graded so they will drain, even if slowly. Wheel ruts that hold water should be filled with bottom ash and covered with stone if they are in a road. See Figures 6 and 7 (next page).

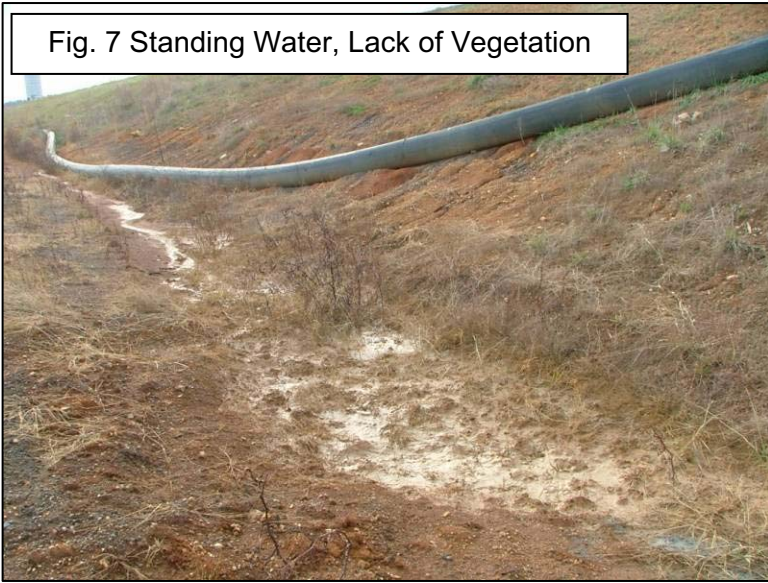
Fig. 7 Standing Water, Lack of Vegetation

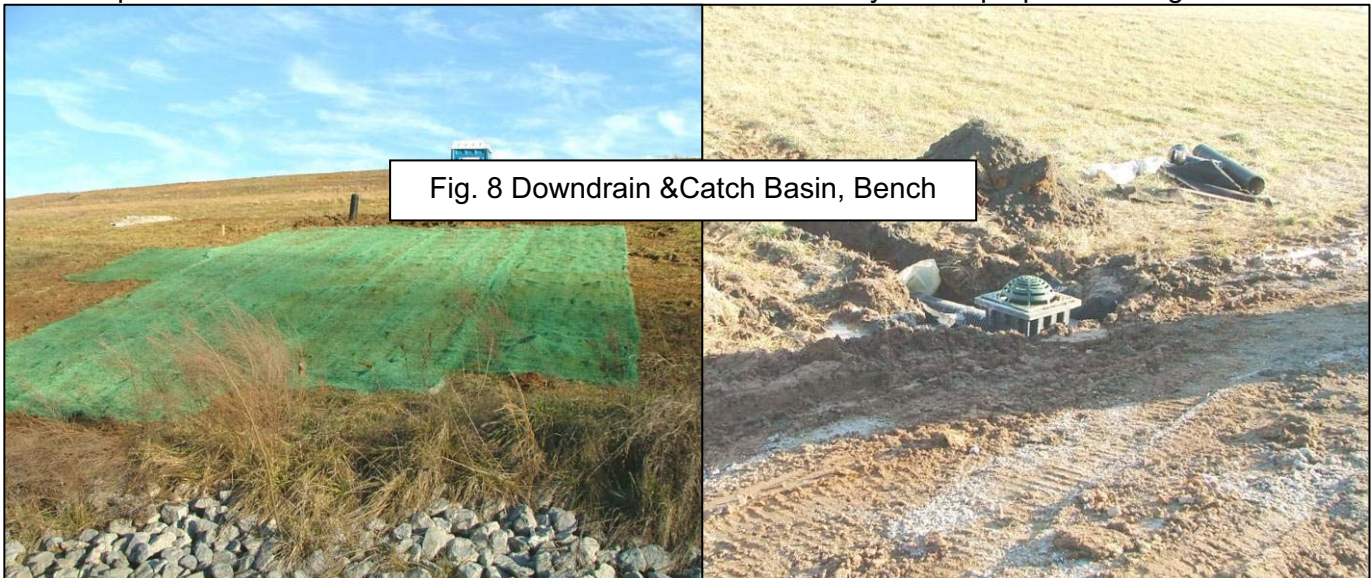
Fig. 8 Downdrain & Catch Basin, Bench

the poor bench drainage. The lower benches will be re-graded to provide positive drainage to a series of catch basins which will divert the water collected to the lower drainage ditch. Construction is currently underway to install surface drainage repairs, (See Figure 8, Figure 9 (next page), and Drawings 10WXXX-1 through -10 for details). In addition to these repairs, outlets are being installed on the old dewatering wells to allow personnel to relieve some of the water in these wells. The water drained will flow to the riprap channel along Swan Pond Road.

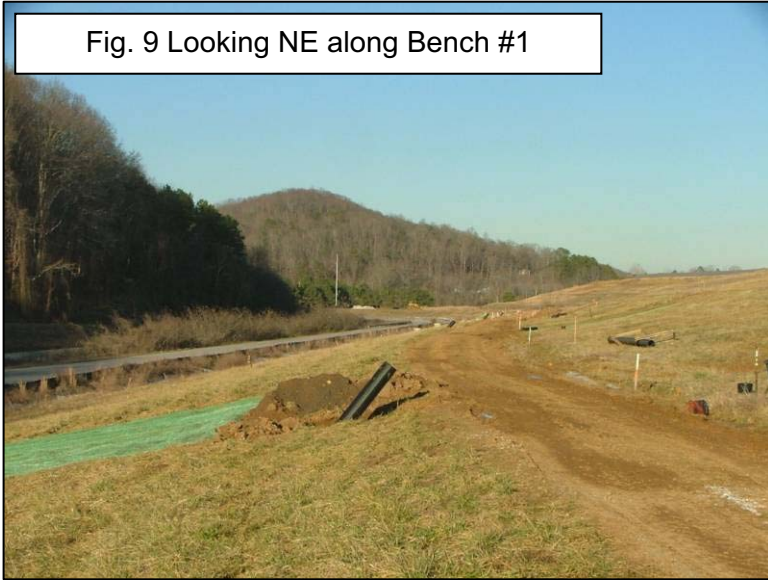
Fig. 9 Looking NE along Bench #1

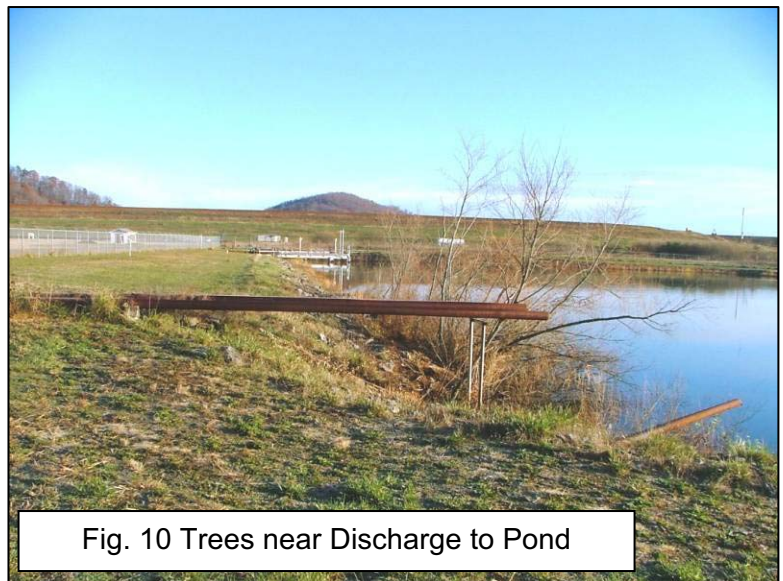
The chemical treatment ponds (iron and copper) are located southwest of the active ash pond. Both ponds were excavated and have no exterior slopes. The internal dike slopes are covered with riprap. These slopes were in good condition with a few trees present. See Figure 10. Sediment in the ponds was tested in FY 2004 and found to be non-hazardous. It appeared that some maintenance had been recently performed at one of the pond platforms. Old gaskets were on the ground and there was a new pipe flange and hardware. The platform at the smaller pond was missing a pump.

Fig. 10 Trees near Discharge to Pond

- Remove trees from the slopes of the dikes. Mowing at least twice a year is recommended to control the size of the trees. Preventing the trees from getting larger than 1" in diameter at the ground is preferred. Any trees larger than 3" in diameter at the base must be pulled from the dikes, roots and all. Repair and reseed the damaged area.

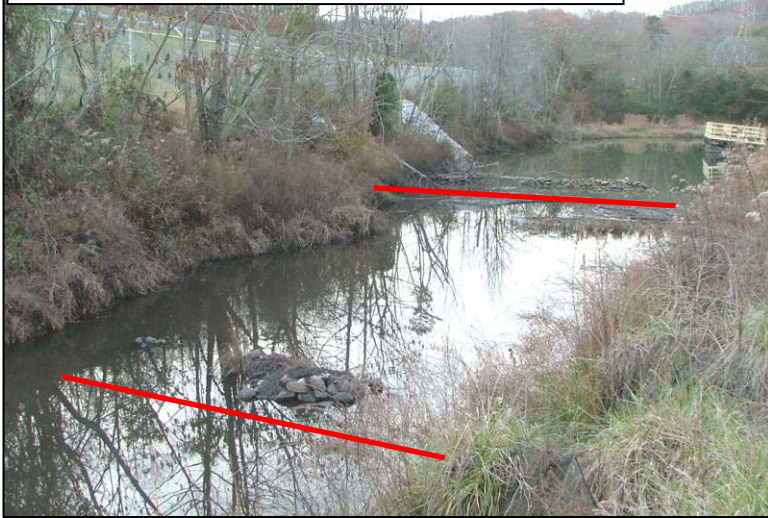
Fig. 11 Breached Check Dams

storage volume contained coal yard sediment. The above figure shows rock check dams built to keep the coal fines away from the pumps. The check dams appear to have been breached, allowing suspended solids to reach the pumps. TVA drawing 10W225-2 (attached as API 2008-2) shows the pond and its intended bottom contours.

- Dredge the Coal Yard Drainage Basin to restore its design contours and protect the pumps from further damage. There is an estimated 2,800+ cubic yards of sediment in the original pond and an extra 3,400+ cubic yards in the "V" section that needs to be removed as soon as reasonable. See the attached copy of 10W225-2. Estimated at \$55,000, depending on haul distance.

- Continue intermittent dredging into the interim dredge cell to inhibit fugitive dusting.
- Re-establish riprap check dams in the coal yard drainage basin to prevent solids away from the pumps.

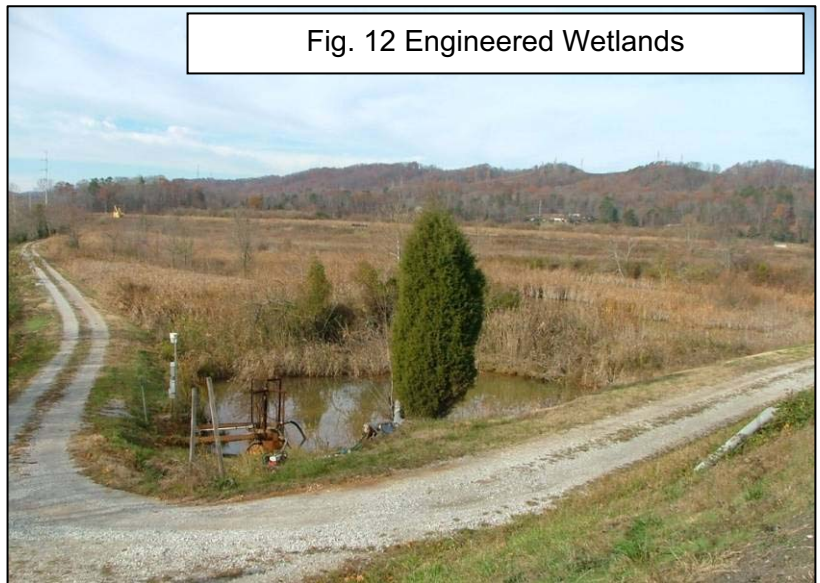
The engineered wetlands along the southwest dike receive seepage that collects in the anoxic limestone drain below the bottom ash trench. The wetland appeared to be functioning, but the discharge is still pumped via two pumps to the ash pond, see Figure 12.

The water levels in the pump structures were at different levels at the time of inspection. There were several trees varying in size growing on the interior dikes of the ponds.

Fig. 12 Engineered Wetlands
